Re: ENF-3-1, Clean Water Act Pretreatment Inspection, Pacific Choice Seafoods

The following information addresses the Areas of Concern that were identified during the Pretreatment inspection of the Pacific Choice Seafood operation in Eureka, CA on August 15, 2018.

In response to Section III, Areas of Concern...Pacific Seafood, Eureka, CA August 15, 2018

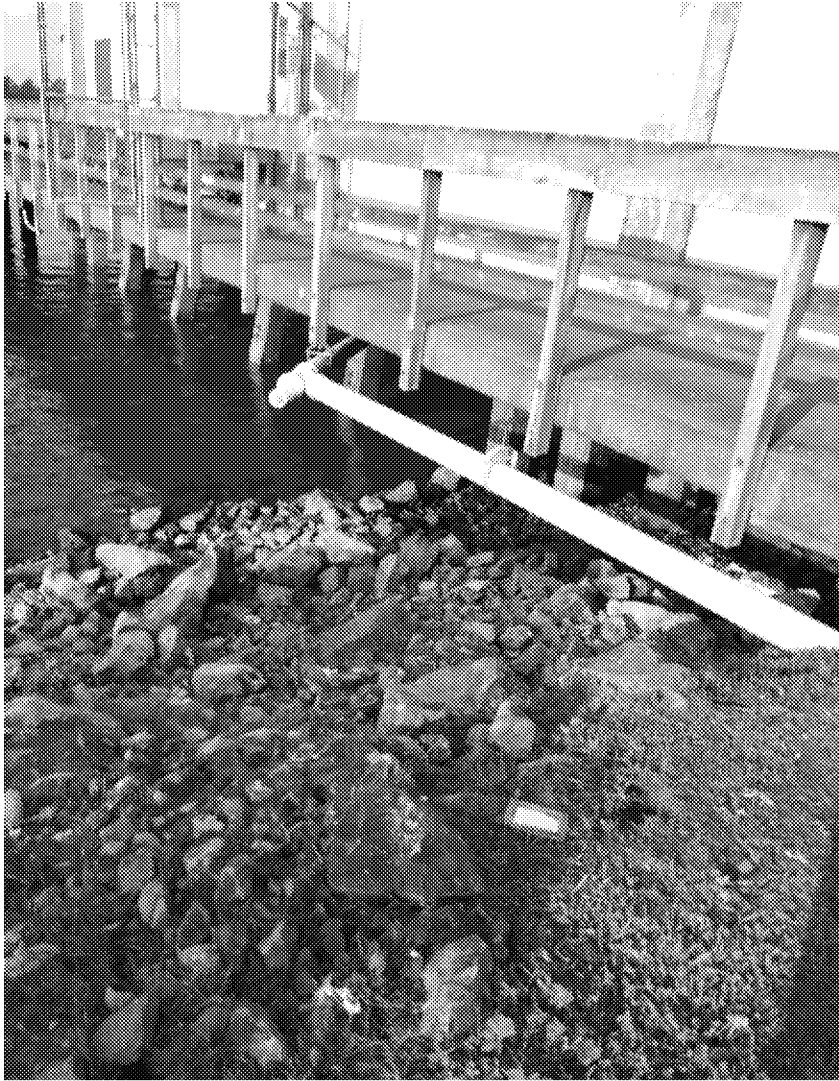
3. Reference Photograph 7, PVC air vent

Photo 2... Ventilation Pipe removed and cap.

- PVC pipe has been removed and capped
- Photo enclosed (Photo 2)

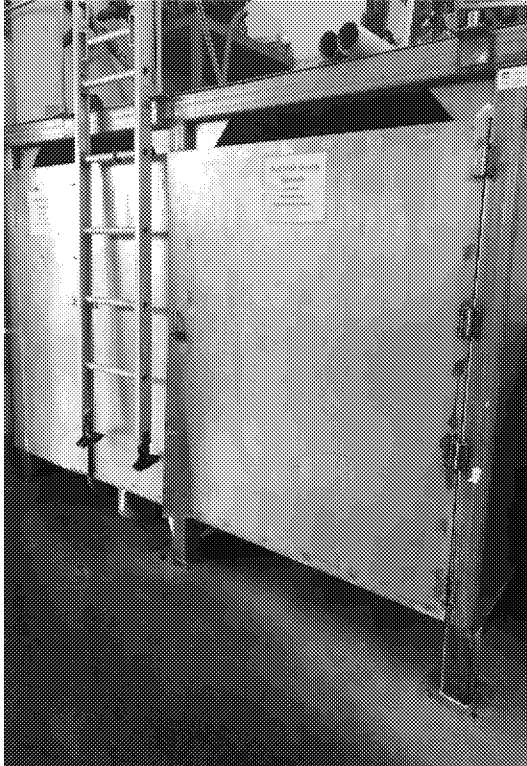
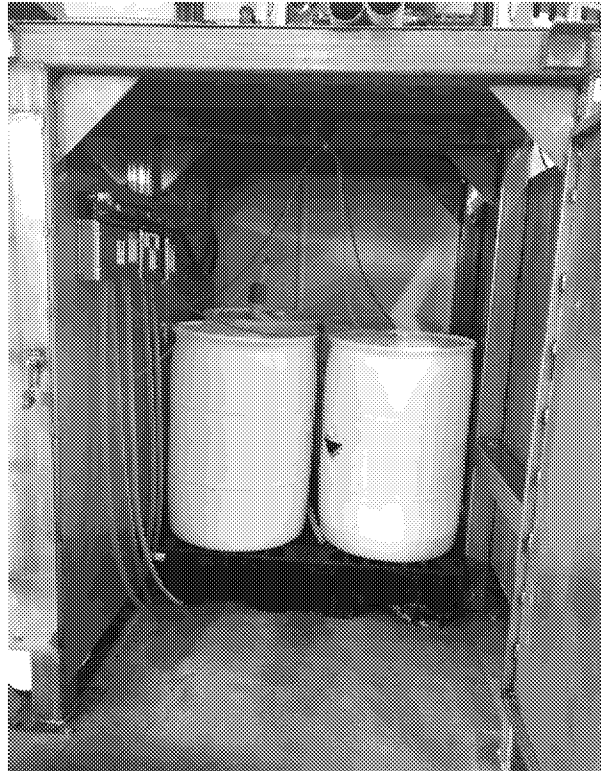
9. Reference Photographs 26 – 28, secondary chemical containment

Photos 3 and 4 Inside Chemical storage and containment

- Outside secondary containment cabin now only houses unopen plastic barrels.
- Inside sanitation chemicals all reside on secondary containment receptacles.
- Photos enclosed (Photos 3, 4, 5 and 6)

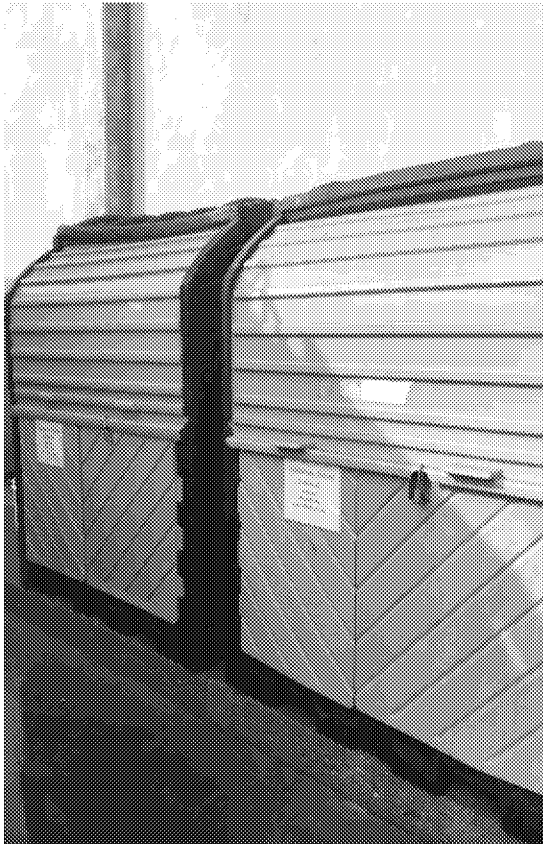
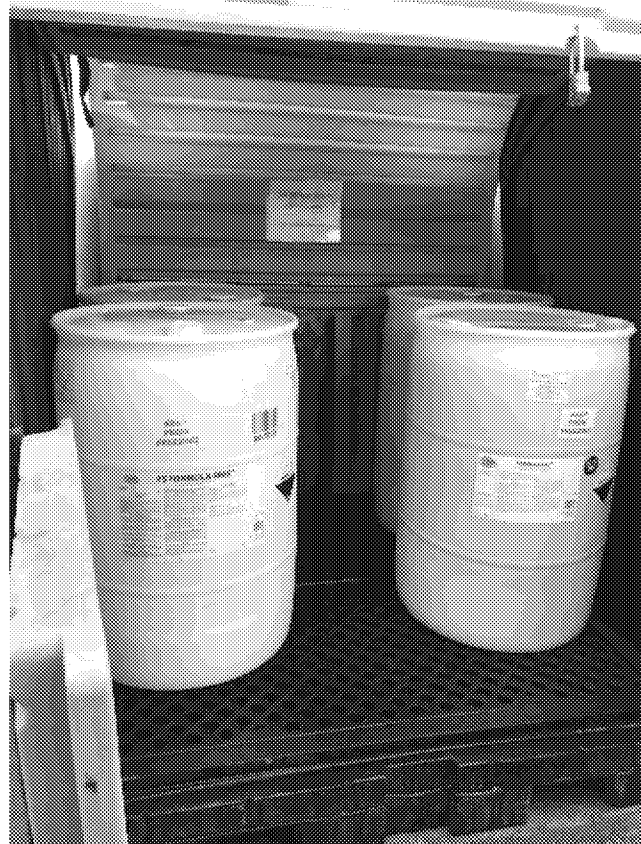
Photos 5 and 6...Outside chemical storage and containment.
